# San Jacinto River Waste Pits

# San Jacinto River Waste Pits Feasibility Study

## **San Jacinto River Waste Pits Update on Armor Cap**

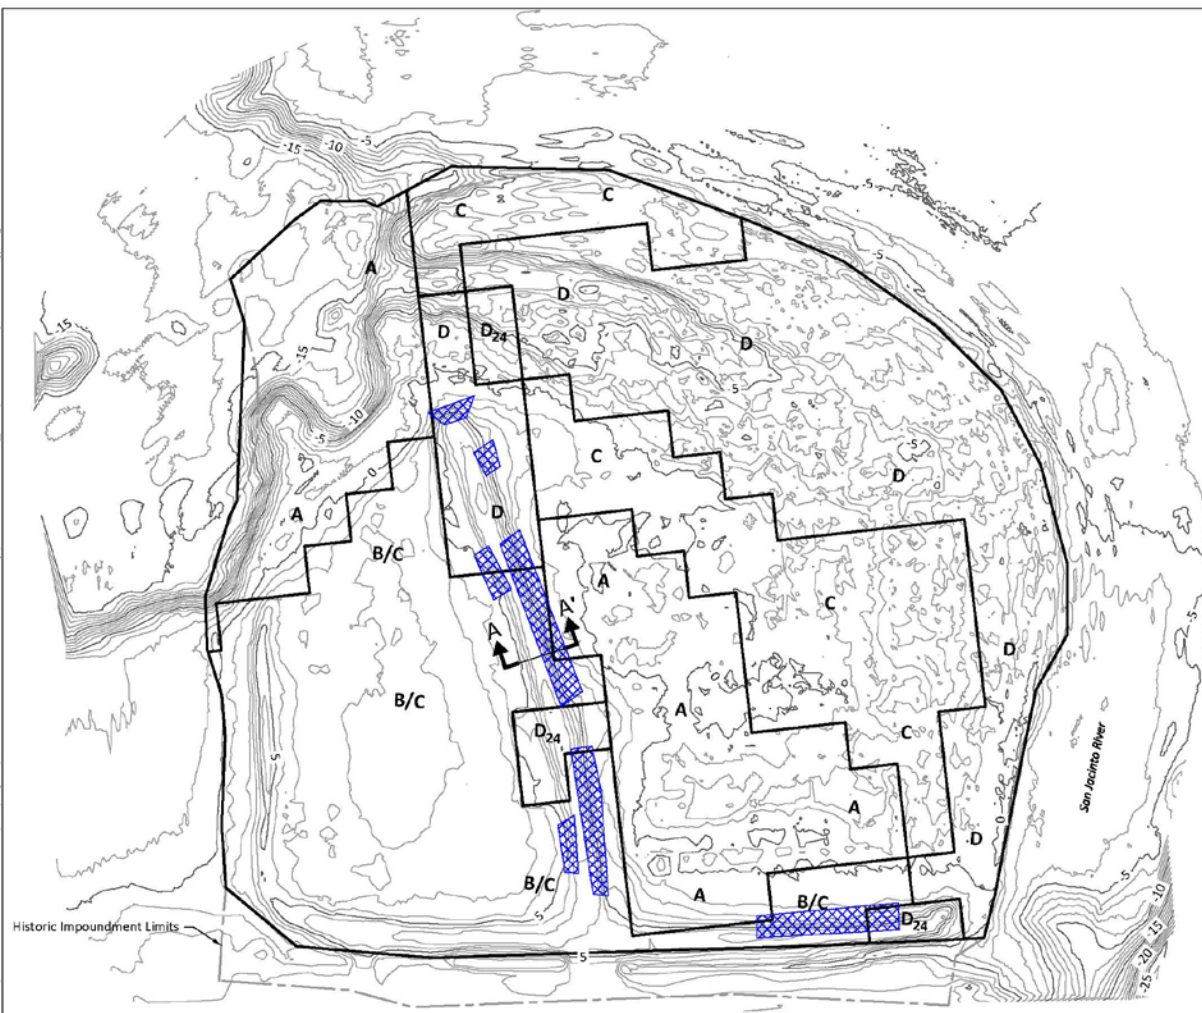
**Figure 1**  
Armor Cap Repair Plan  
San Jacinto River Waste Pits Superfund Site

- TCRA cap erosion repaired in August 2012. The US Army Corps of Engineers reviewed the cap design and construction and determined that there are deficiencies (including slope and grading of cap materials).
- On November 1, 2013, EPA notified the Potentially Responsible Parties to address the TCRA cap design and construction protectiveness issues until the final Site remedy is selected.
- PRPs submitted armor cap “Enhancement” work plan on 11/27/13, and EPA approved plan on 01/10/14.
- Construction repairs on armor cap begin on 01/17/2014

**Fig. 1 – Armor Cap Enhancement Work Plan - Armor cap D placement areas with improved slope construction**

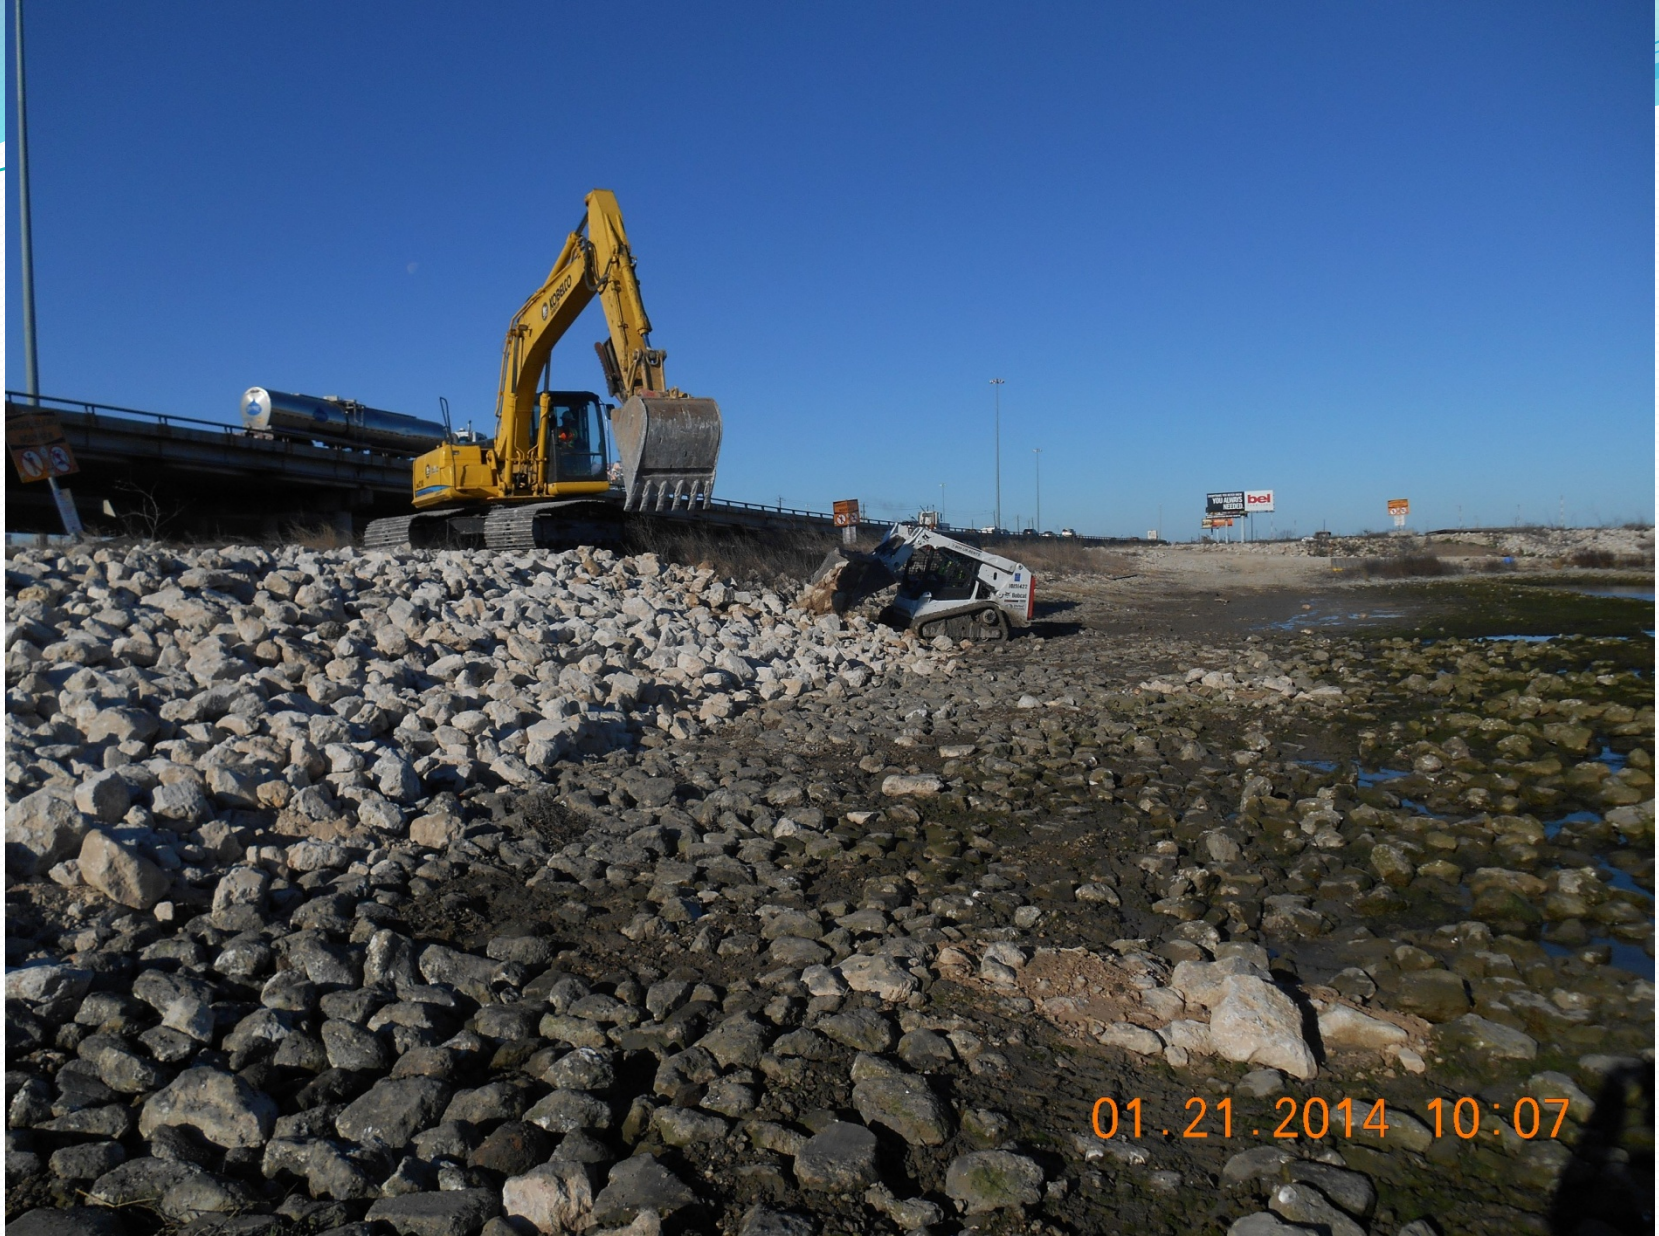
**Constructing enhanced slope along the South Berm in the Eastern Cell using an excavator (for grading the rock) and skid steer (for transporting rock from the stockpile and placing it)– 1-21-2014**

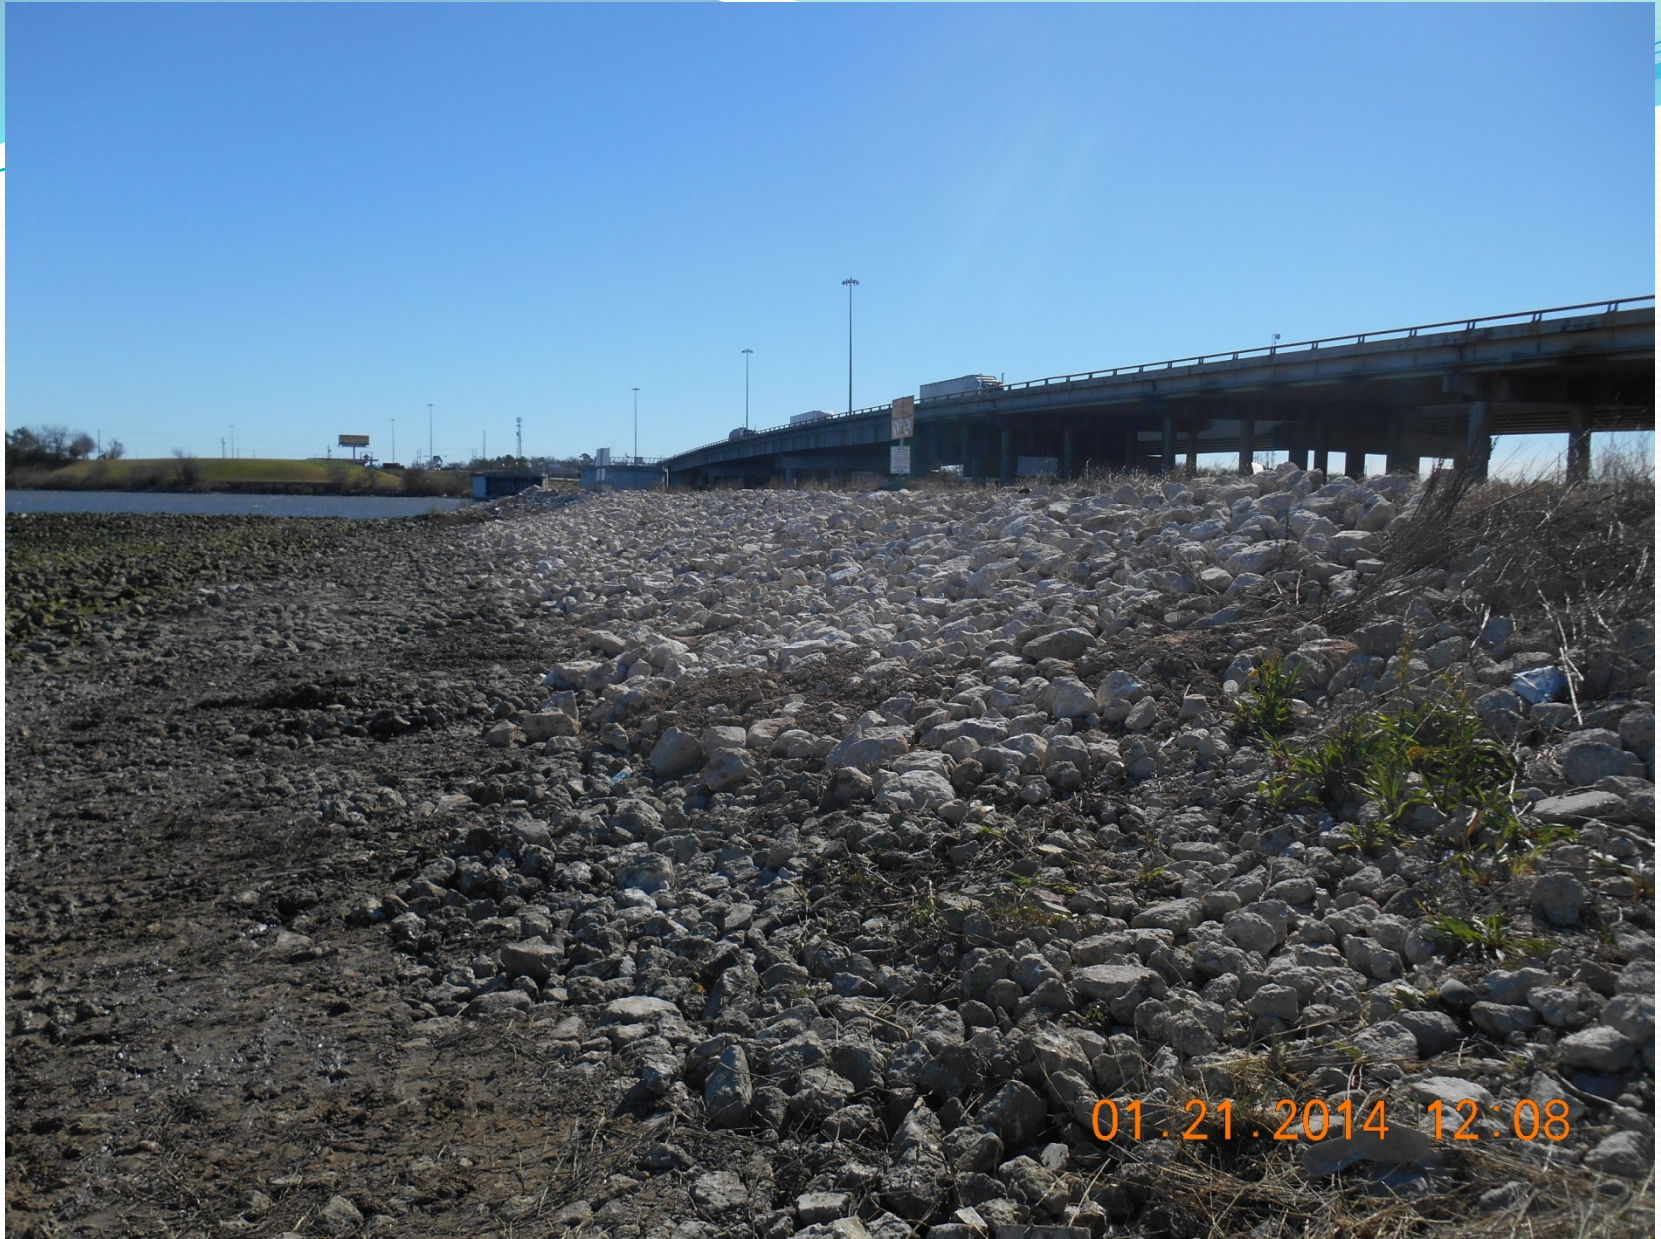
**South Berm in the Eastern Cell after completion of the enhancement work  
-1-21-2014**

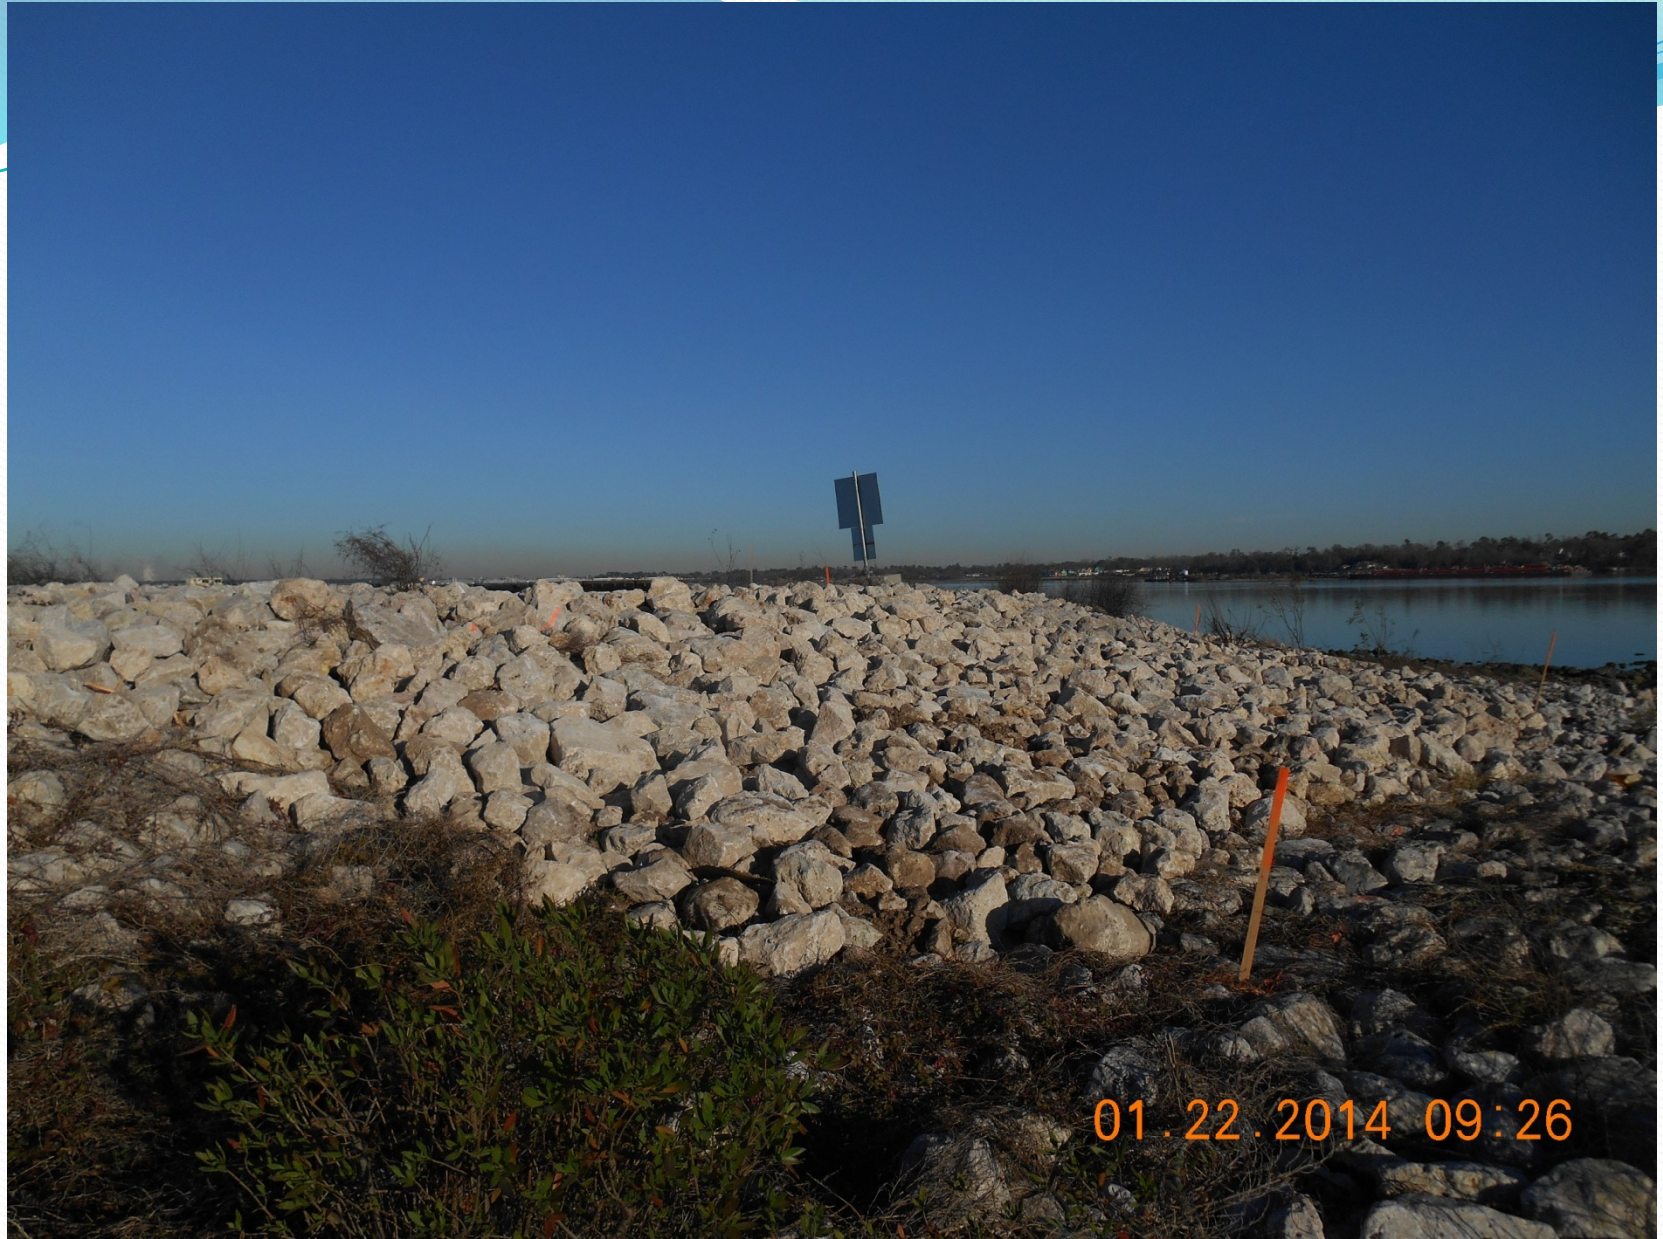
**Central Berm on the eastern slope, near the north end of the berm, after completion of the enhancement work 1-22-2014**
